IR₂MA
Large Scale Irrigation
Management Tools for
Sustainable Water
Management in Rural
Areas and Protection
of Receiving Aquatic
Ecosystems

Deliverable 4.4.2

Results presentation

Hydraulic Performance Analysis of On-Demand Pressurized Irrigation Systems in irrigation district 17 (Sinistra Ofanto)

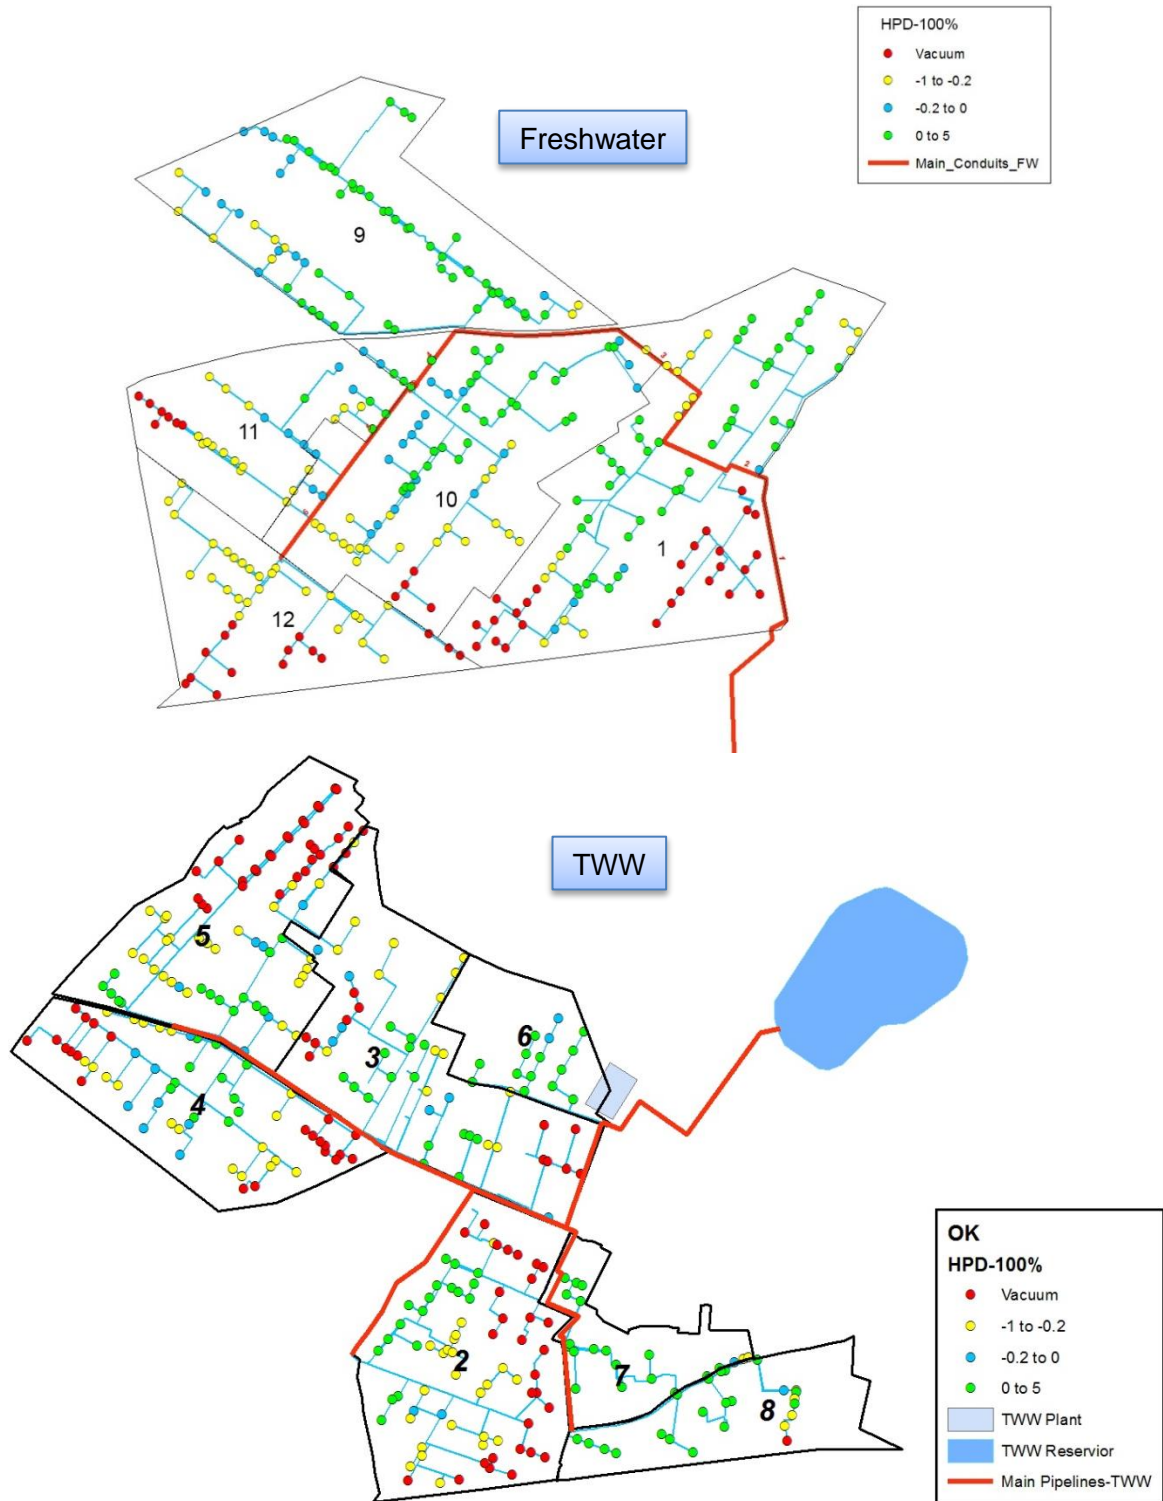
Fig. 15. GIS representation of the 100% pressure deficit of the sub-network 1 (freshwater) and sub-network 2 (TWW).

Figure 15 shows the values of the 100% pressure deficit symbolized in GIS. For sub-network 1 (freshwater) the hydrants with bad performance (red color) are distributed in sectors 1, 10, 11, and 12. Hydrants with relatively poor performance (yellow color) are present in all sectors. In the 90% pressure deficit, most of the red hydrants turned green, yellow, or blue identifying a more stable system. Figure 15 indicates that hydrants of vacuum pressure are affecting the system performance for sub-network 2 (TWW), and they are present in sectors 2, 3, 4, 5, and 8. It is noticed also they are located in the area far from the pumping station at terminal points of the network. Additionally, hydrants with a pressure deficit of -1 to -0.2 (yellow color) are seen in almost all sectors. From Figure 16, negative pressure hydrants are reduced when contrasted with the 100% deficit values. Again, the probability that 90% pressure deficit vales will be exceeded is only 10%, but it happened, there will be a dangerous situation represented in Figure 15.

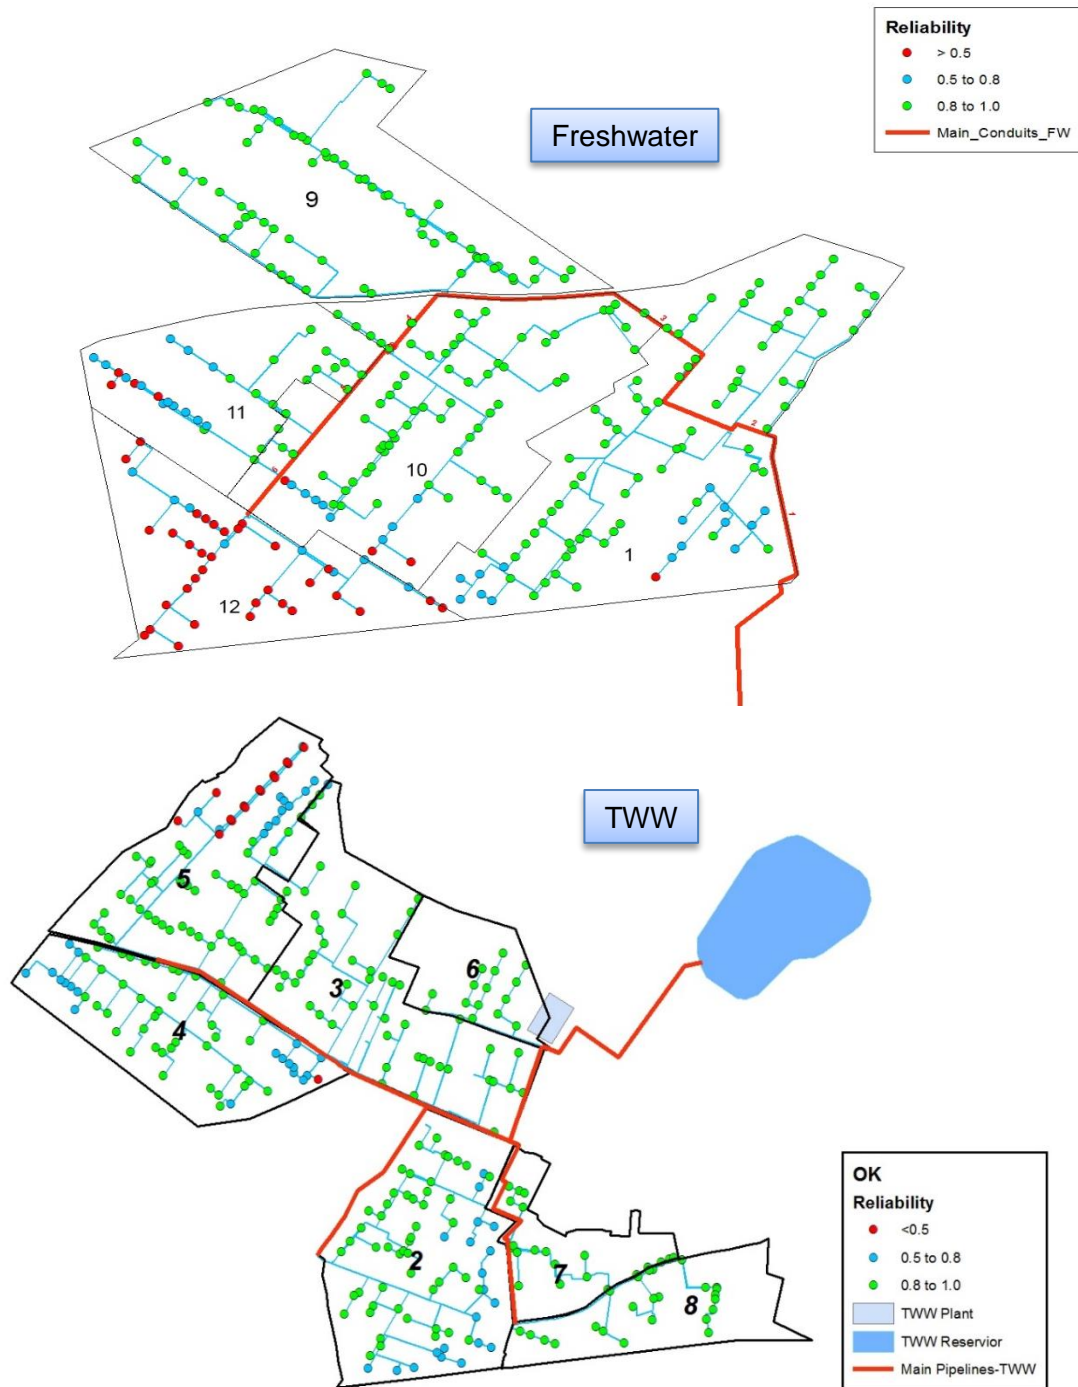
Fig. 17. GIS representation of the reliability of each hydrant for sub-network 1 (freshwater) and sub-network 2 (TWW).

The reliability of each hydrant is represented in Figure 17. For sub-network 1, hydrants with low reliability were detected for sector 12. For sub-network 2 (TWW), the green color is the prevalent color in almost all sectors, which indicates a reliable system except for some hydrants especially those

in red color in sector 5. Nevertheless, as mentioned before, the reliability itself is not enough to represent the system performance.

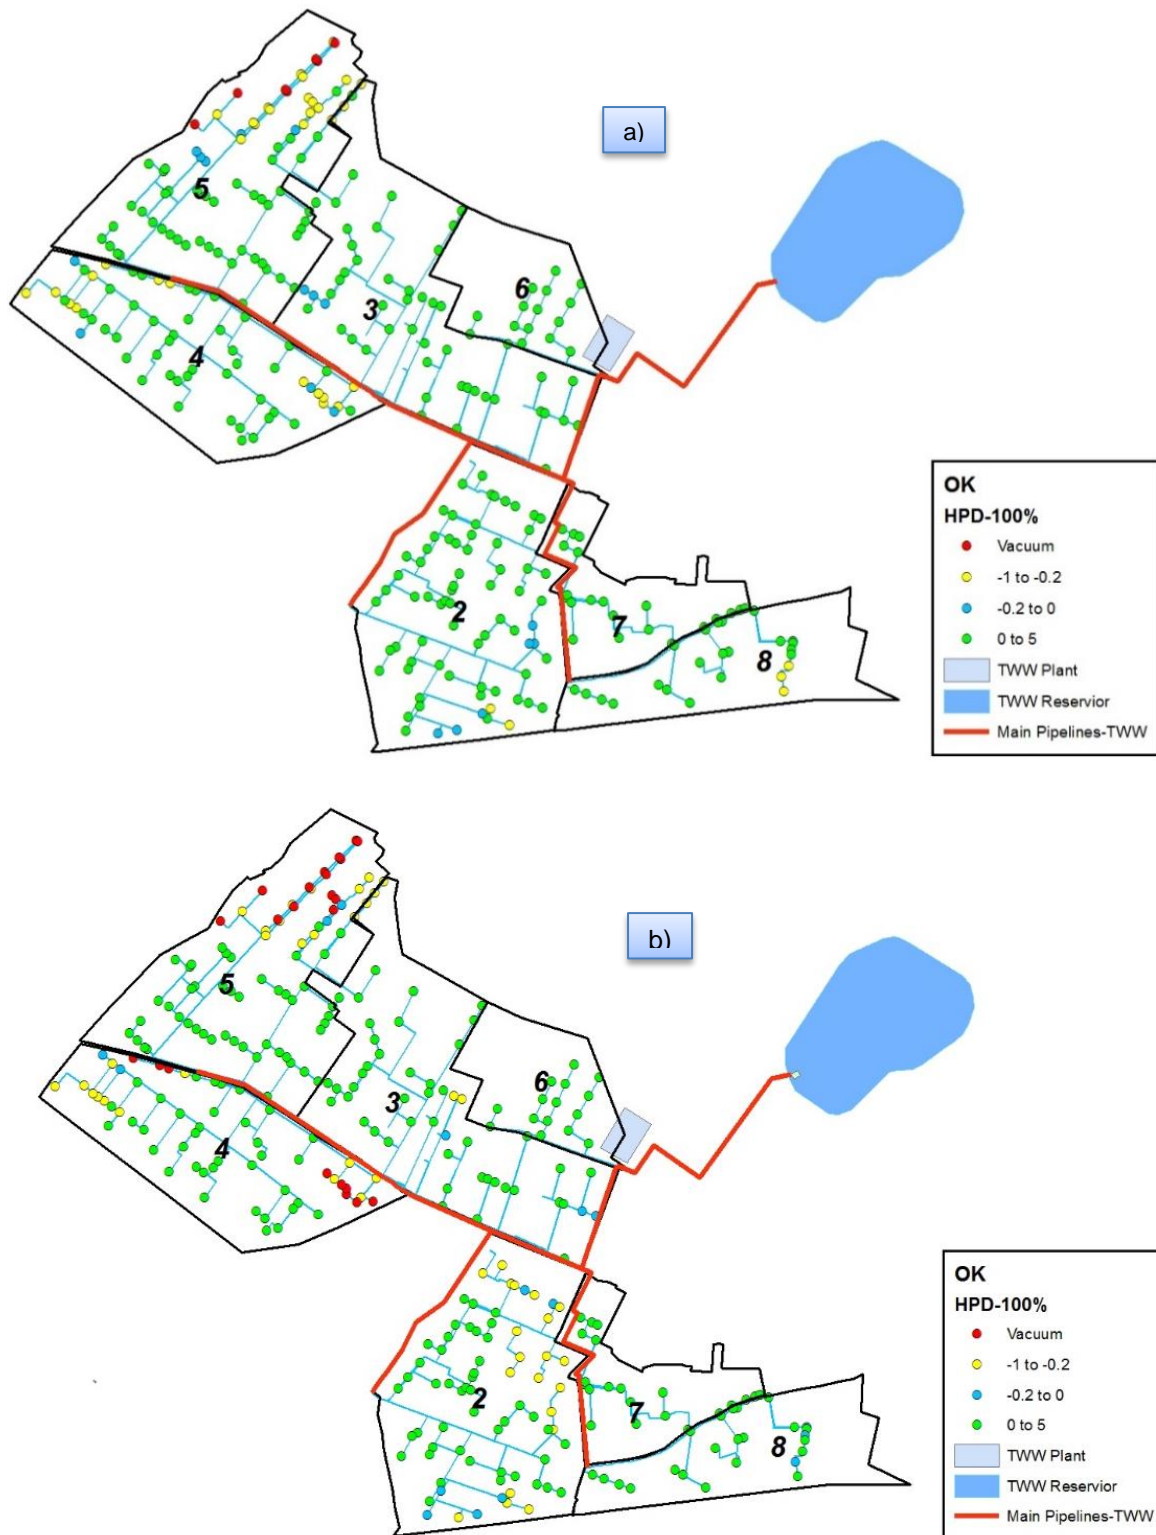
Fig. 24. GIS representation for 100% pressure deficit of each hydrant for sub-network 2. (a) Average year (b) Dry year.

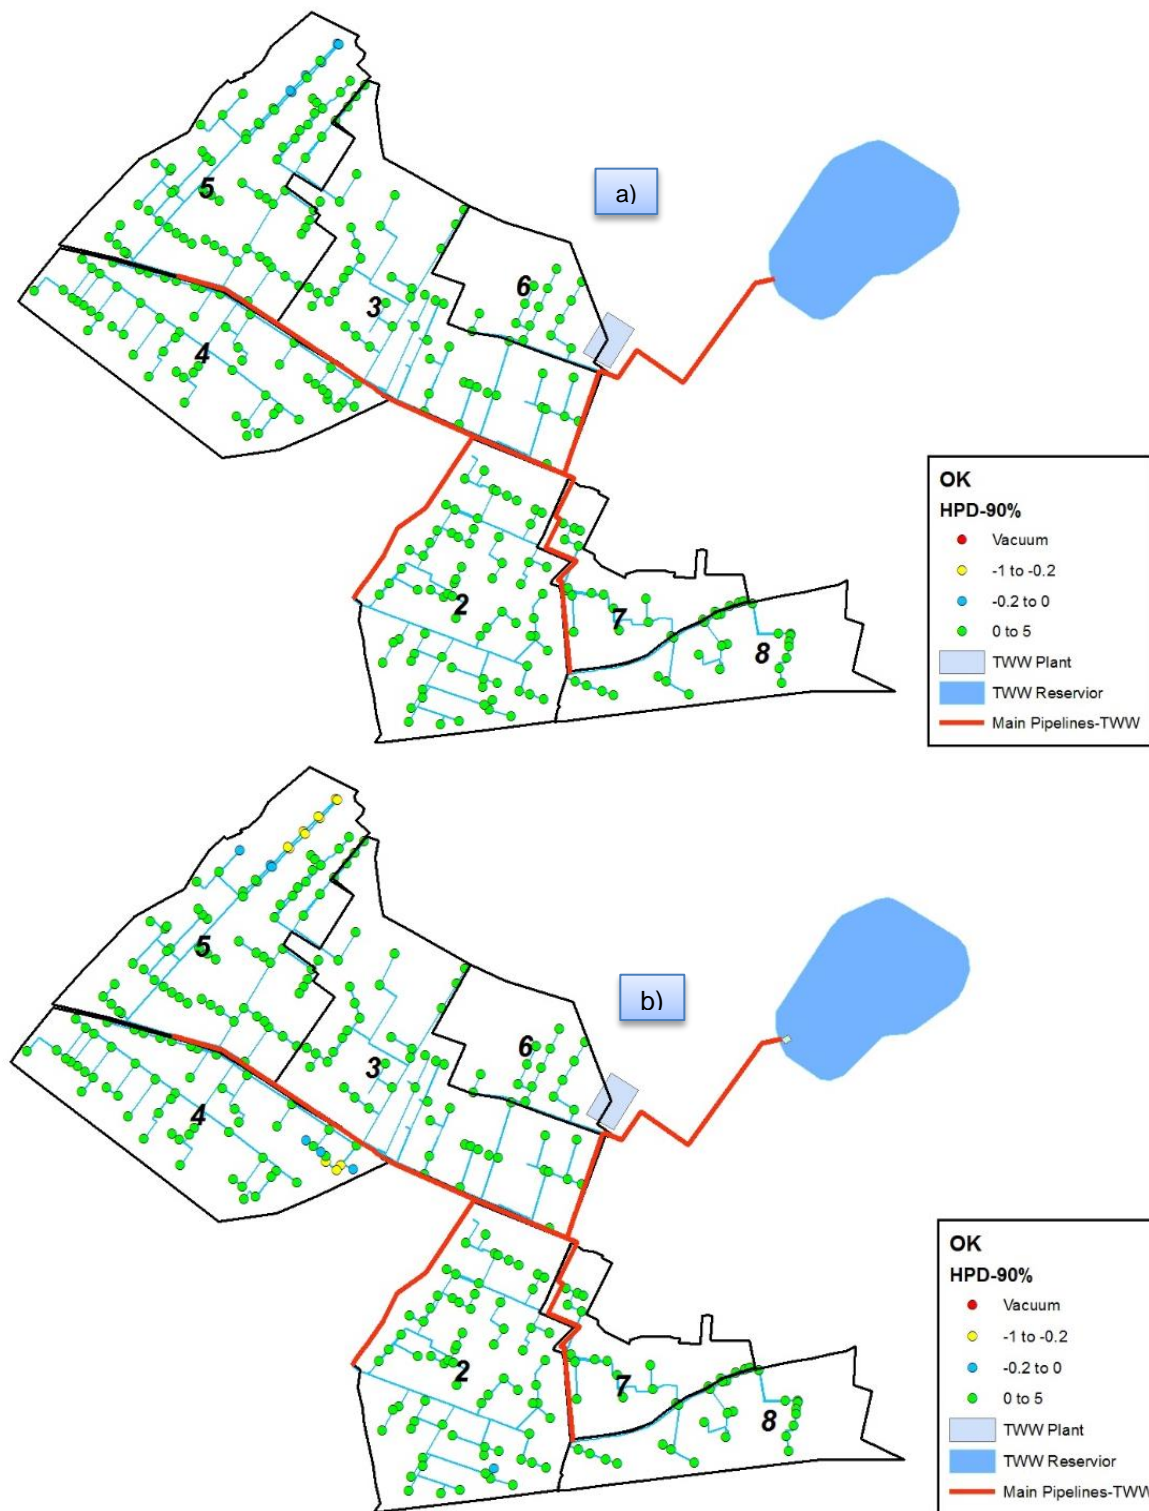
Fig. 25. GIS representation for 90% pressure deficit of each hydrant for sub-network 2. (a) Average year (b) Dry year.
